**Flood Control Project Maintenance
Levee Inspections**

Maintenance Issue Types Only, Levee Inspection Report By Mile - Spring 2017

Reclamation District No. 1000 Natomas

Waterway	Bank	Unit Miles	Inspection Start/End	Inspector
Unit No. 01 Sacramento River	Left	18.28	03/17/2017 03/17/2017	Sterling York

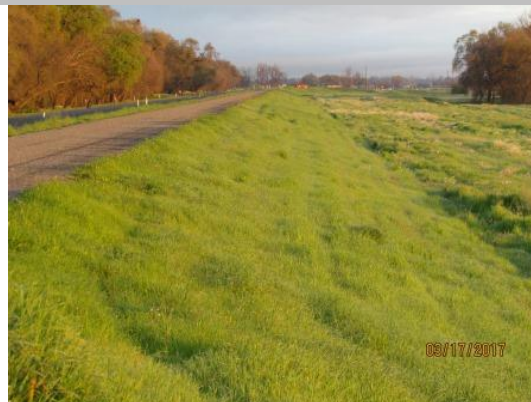
Photo 1 of 1 : SP_2017_RD1000_31_17_20170327_00048.jpg

LM Start	0.01	Rating **	A/W	Issue No.	17
LM End	12.38	Issue Type +	Ma	Location *	LS
Category	Earthen Levee		GPS Latitude/Longitude		
			Start	End	
Item	Vegetation		38.780399 °	38.649214 °	
			-121.603230 °	-121.569931 °	
DWR ID	DWR_RD1000_01_s_2017_17				
Comment Code					
V1 : Control annual grass and weeds on the levee slopes and easements.					
Inspector Comment					
Annual grass are starting to get a little to tall, the RD has started their spraying, Spring 2017.

View of annual grasses land side, that need to be maintained. The RD has started their spraying for spring of 2017.

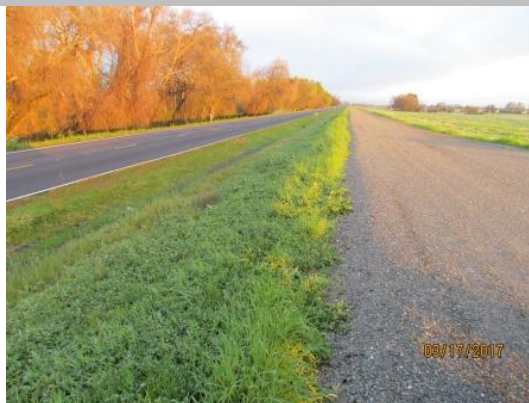
Photo 1 of 1 : SP_2017_RD1000_31_64_20170327_00049.jpg

LM Start	0.01	Rating **	A/W	Issue No.	64
LM End	12.38	Issue Type +	Ma	Location *	WS
Category	Earthen Levee			GPS Latitude/Longitude	
				Start	End
Item	Vegetation			38.780399 °	38.649234 °
				-121.603298 °	-121.569942 °
DWR ID	DWR_RD1000_01_s_2017_64				
Comment Code					
V1 : Control annual grass and weeds on the levee slopes and easements.					
Inspector Comment					
Annual grass are starting to get a little to tall, the RD has started their spraying, Spring 2017.

View of annual grasses water side, that need to be maintained. The RD has started their spraying for spring of 2017.

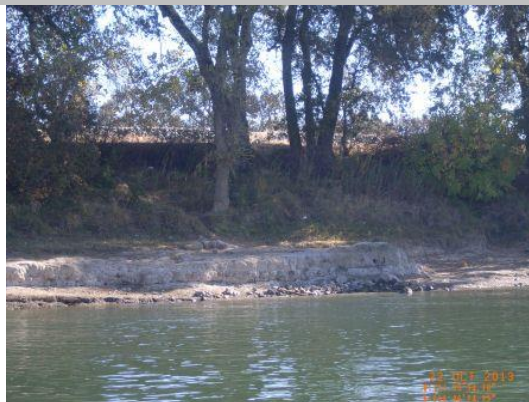
Photo 1 of 1 : SP_2017_RD1000_31_3_20170316_00002.jpg

LM Start	0.48	Rating **	M	Issue No.	3
LM End	0.61	Issue Type +	Ma	Location *	WS
Category	Supplemental			GPS Latitude/Longitude	
				Start	End
Item	2015 USACE Erosion Survey, DRAFT			38.774507 °	38.772921 °
				-121.598865 °	-121.597788 °
DWR ID	DWR_RD1000_01_s_2016_3				
Comment Code					
Inspector Comment					
1997 - Very cohesive toe. 2005 - Site was staked and rock was stockpiled along the top of the bank. 2010 - New adjacent levee under construction. 2011 - New animal burrow. 2015: No observed changes. [2015 Site ID: SAC_78-3_L]

USACE 2013 Photo #1

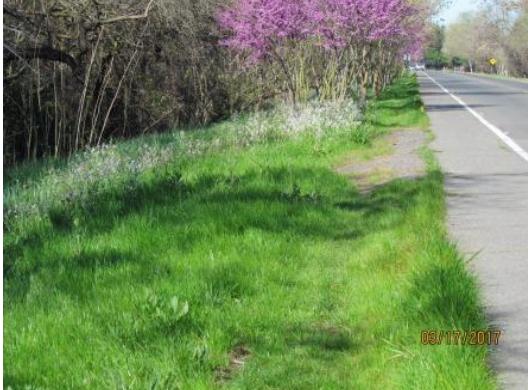
Photo 1 of 1 : SP_2017_RD1000_32_6_20170327_00008.jpg

View of annual grass water side, that are starting to get to tall, the RD has started their spraying, Spring 2017.

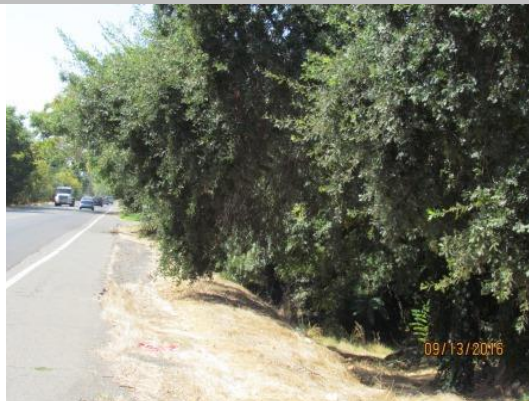
Photo 1 of 1 : SP_2017_RD1000_32_4_20170316_00006.jpg

LM Start	1.06	Rating **	A/W	Issue No.	4
LM End	1.48	Issue Type +	Ma	Location *	LS
Category	Earthen Levee			GPS Latitude/Longitude	
				Start	End
Item	Trim / Thin Trees			38.608536 °	38.608063 °
				-121.492653 °	-121.484951 °
DWR ID	DWR_RD1000_02_f_2016_4				
Comment Code					
T1 : Trim trees to at least five feet above ground level.					
Inspector Comment					
Trees have been trimmed high enough to allow visibility down to the levee toe. Spring 2017.

View looking downstream landside of trees that need to be trimmed. Fall 2016.

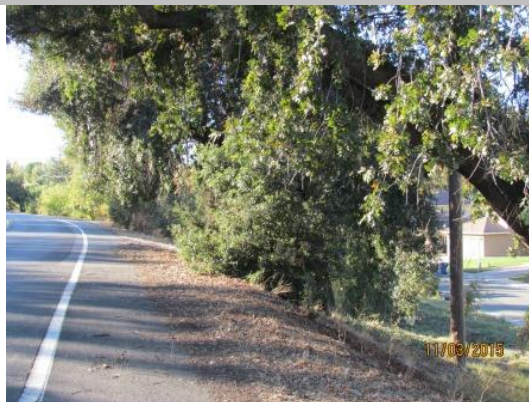
Photo 1 of 1 : SP_2017_RD1000_32_2_20170316_00004.jpg

LM Start	1.54	Rating **	A/W	Issue No.	2
LM End	1.61	Issue Type +	Ma	Location *	LS
Category	Earthen Levee			GPS Latitude/Longitude	
				Start	End
Item	Trim / Thin Trees			38.607978 °	38.607713 °
				-121.483858 °	-121.482524 °
DWR ID	DWR_RD1000_02_s_2014_2				
Comment Code					
T2 : Thin trees to allow visibility of the ground and room to flood fight.					
Inspector Comment					
Trees have been trimmed high enough to allow visibility down to the levee toe. Spring 2017.

View of the trees on the landside levee slope. Small trees 4" in diameter at chest height should be removed before they get to big.

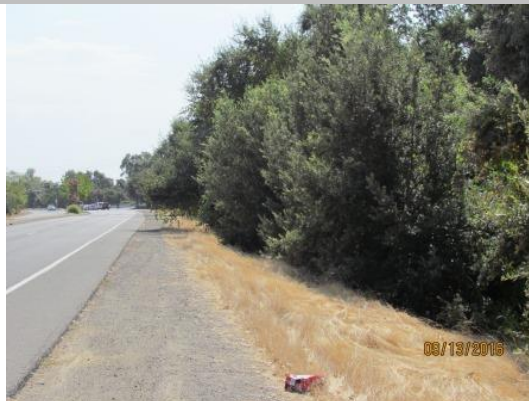
Photo 1 of 1 : SP_2017_RD1000_32_3_20170316_00005.jpg

LM Start	1.79	Rating **	A/W	Issue No.	3
LM End	2.07	Issue Type +	Ma	Location *	WS
Category	Earthen Levee			GPS Latitude/Longitude	
				Start	End
Item	Trim / Thin Trees			38.606566 °	38.605012 °
				-121.479695 °	-121.474813 °
DWR ID	DWR_RD1000_02_f_2016_3				
Comment Code					
T1 : Trim trees to at least five feet above ground level.					
Inspector Comment					
Trees have been trimmed high enough to allow visibility over 20 feet down the water side slope. Spring 2017.

View looking upstream waterside of trees that need to be trimmed. Fall 2016.

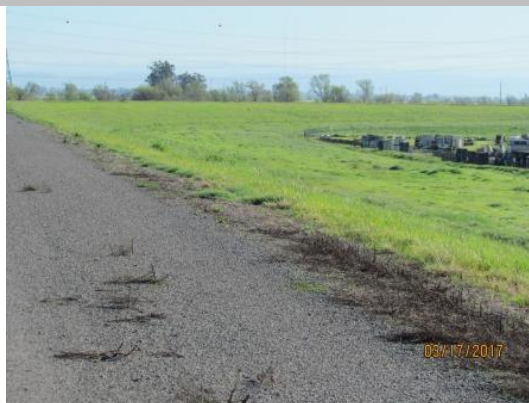
Photo 1 of 1 : SP_2017_RD1000_33_6_20170327_00017.jpg

LM Start	0.00	Rating **	M	Issue No.	6
LM End	16.93	Issue Type +	Ma	Location *	LS
Category	Earthen Levee			GPS Latitude/Longitude	
				Start	End
Item	Vegetation			38.606034 °	38.820669 °
				-121.470572 °	-121.543751 °
DWR ID	DWR_RD1000_03_s_2017_6				
Comment Code					
V1 : Control annual grass and weeds on the levee slopes and easements.					
Inspector Comment					
Annual grass are starting to get a little to tall, the RD has started their spraying, Spring 2017.

View of annual grass land side, that are starting to get a little to tall, the RD has started their spraying, Spring 2017.

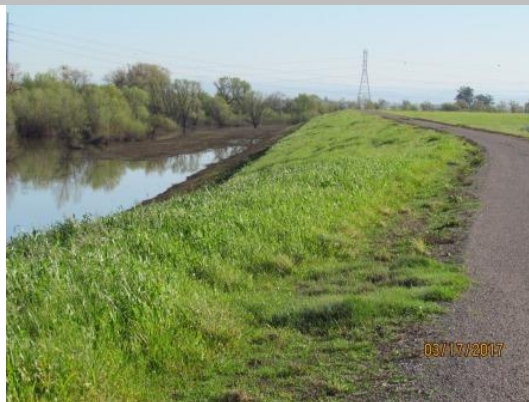
Photo 1 of 1 : SP_2017_RD1000_33_11_20170327_00018.jpg

LM Start	0.00	Rating **	M	Issue No.	11
LM End	16.93	Issue Type +	Ma	Location *	WS
Category	Earthen Levee			GPS Latitude/Longitude	
				Start	End
Item	Vegetation			38.606034 °	38.820745 °
				-121.470572 °	-121.543700 °
DWR ID	DWR_RD1000_03_s_2017_11				
Comment Code					
V1 : Control annual grass and weeds on the levee slopes and easements.					
Inspector Comment					
Annual grass are starting to get a little to tall, the RD has started their spraying, Spring 2017.

View of annual grass water side, that are starting to get a little to tall, the RD has started their spraying, Spring 2017.

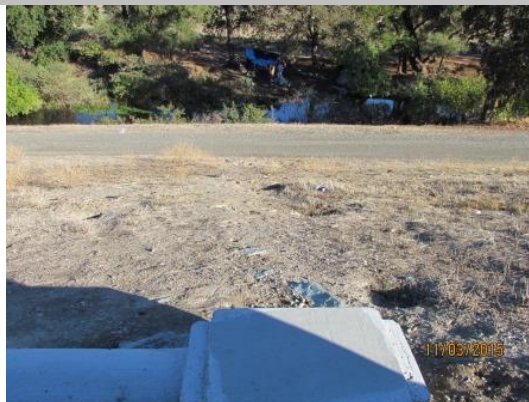
Photo 1 of 2 : SP_2017_RD1000_33_19_20170316_00013.jpg

LM Start	0.38	Rating **	M	Issue No.	19
LM End	0.38	Issue Type +	Ma	Location *	LS
Category	Earthen Levee			GPS Latitude/Longitude	
				Start	End
Item	Animal Control			38.610854 °	38.610854 °
				-121.467961 °	-121.467961 °
DWR ID	DWR_RD1000_03_f_2015_19				
Comment Code					
A3 : No rodents visible, but rodent burrows visible; need to backfill and compact or grout burrows.					
Inspector Comment					
Bait injection into rodent hole for control. No sign of rodents Fall 2016.

View of the rodent holes on the waterside levee slope. Fall 2015. Bait injection into rodent hole for control, no sign of rodents Fall 2016.

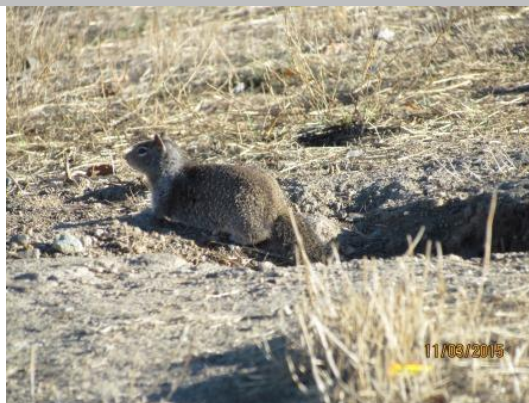
Photo 2 of 2 : SP_2017_RD1000_33_19_20170316_00014.jpg

LM Start	0.38	Rating **	M	Issue No.	19 (cont)	
LM End	0.38	Issue Type +	Ma	Location *	LS	
Category	Earthen Levee			GPS Latitude/Longitude		
				Start		End
Item	Animal Control			38.610854 °		38.610854 °
				-121.467961 °		-121.467961 °
DWR ID	DWR_RD1000_03_f_2015_19					
Comment Code						
A3 : No rodents visible, but rodent burrows visible; need to backfill and compact or grout burrows.						
Inspector Comment						
Bait injection into rodent hole for control. No sign of rodents Fall 2016.

View of the rodent on the waterside levee slope ready to retreat into the den, penetrating the levee prism.

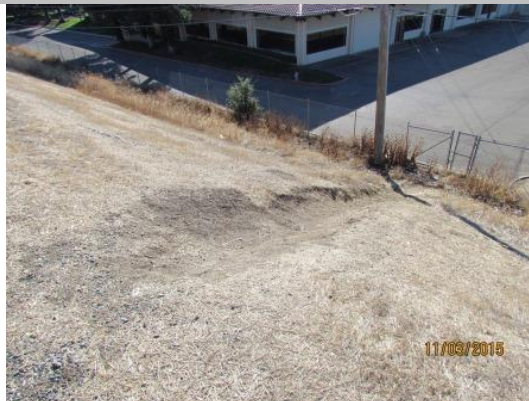
Photo 1 of 1 : SP_2017_RD1000_33_15_20170316_00011.jpg

LM Start	2.36	Rating **	M	Issue No.	15
LM End	2.36	Issue Type +	Ma	Location *	LS
Category	Earthen Levee			GPS Latitude/Longitude	
				Start	End
Item	Slope Stability			38.639326 °	38.639326 °
				-121.473107 °	-121.473107 °
DWR ID	DWR_RD1000_03_f_2015_15				
Comment Code					
S2 : Repair the levee slope damaged by foot traffic and prevent access where possible.					
Inspector Comment

View of the landside levee slope damaged by foot traffic.

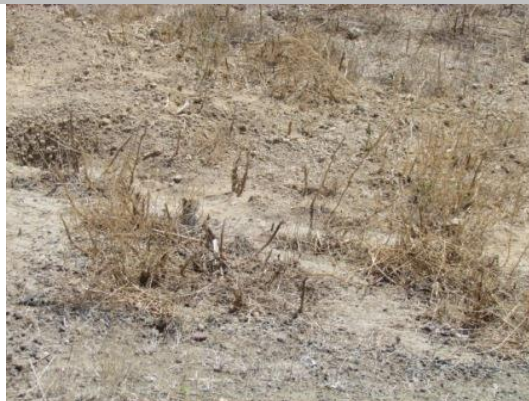
Photo 1 of 2 : SP_2017_RD1000_33_1_20170316_00001.jpg

LM Start	4.78	Rating **	M	Issue No.	1
LM End	4.89	Issue Type +	Ma	Location *	LS
Category	Earthen Levee			GPS Latitude/Longitude	
				Start	End
Item	Animal Control			38.672913 °	38.673685 °
				-121.481364 °	-121.483115 °
DWR ID	DWR_RD1000_03_f_2013_1				
Comment Code					
A3 : No rodents visible, but rodent burrows visible; need to backfill and compact or grout burrows.					
Inspector Comment					
Several bait traps line the levee toe, no sign of rodents.

This photo was taken from the levee crown looking down the landward slope at a squirrel poking its head out of a hole. Fall 2014.

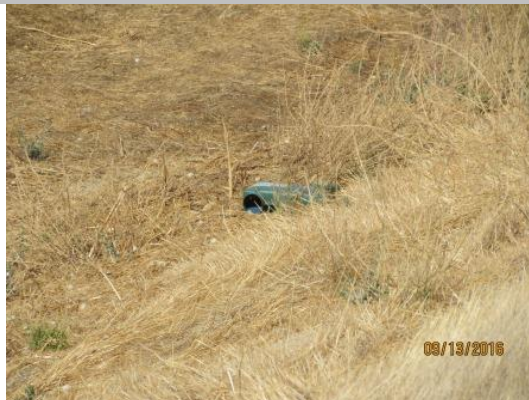
Photo 2 of 2 : SP_2017_RD1000_33_1_20170316_00002.jpg

Updated view taken facing the landside looking upstream at bait trap. Rodent holes have been filled and no new activity was observed. Several bait traps at landside levee toe. Fall 2016.
